**Flood Control Project Maintenance  
Levee Inspections  
LMA District Cover Sheet  
Spring 2012 Levee Inspection Results**

**Reclamation District No. 0556 Upper Andrus**

**Spring 2012 Levee Inspection Results**

Waterway		Bank	Unit Miles
Unit No. 01 Georgiana Slough		Right	5.47

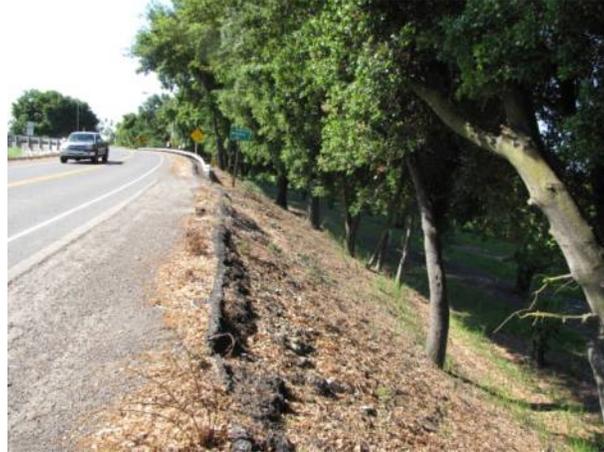
Levee Mile Report Line	4
Start Levee Mile	0.00
End Levee Mile	0.00
Location	Land Side
Category	Earthen Levee
Item	Vegetation
Unit 1 RD 556 Land side looking downstream from levee mile 0.00. Photo taken 4-27-2012.	
phillips_s_20120507_407.jpg

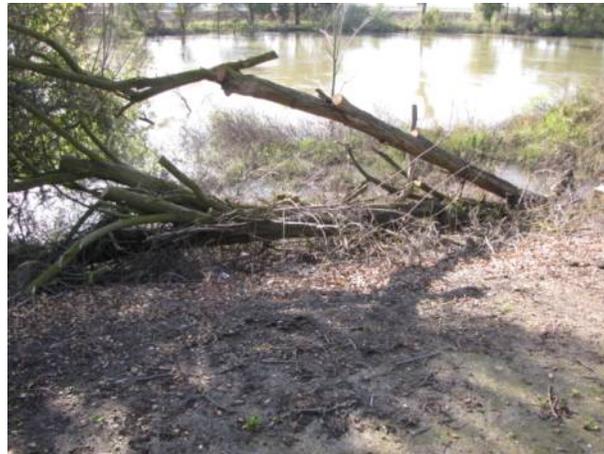
Levee Mile Report Line	6
Start Levee Mile	0.42
End Levee Mile	0.42
Location	Water Side
Category	Earthen Levee
Item	Encroachments
Looking downstream from levee mile 0.42 two fallen trees on waterward slope. Photo taken 3-29-2011	
phillips_s_20120306_246.jpg

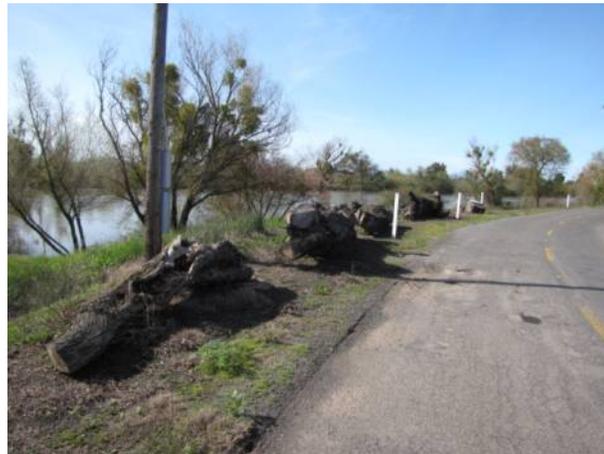
Levee Mile Report Line	14
Start Levee Mile	1.55
End Levee Mile	1.57
Location	Water Side
Category	Earthen Levee
Item	Encroachments
The land owner stated that he would have these trees removed from levee section next month (April). Photo taken 3-29-2011.	
phillips_s_20120306_245.jpg

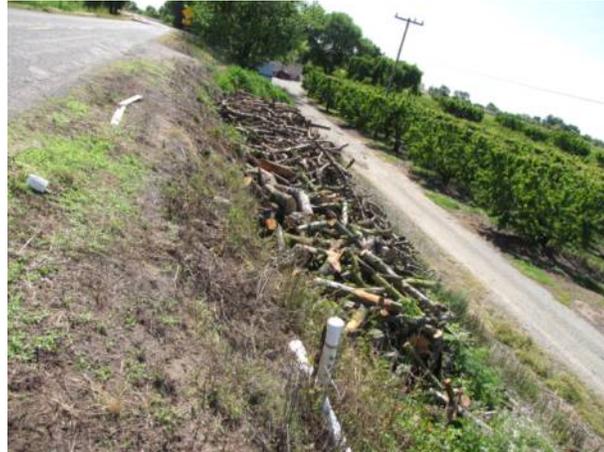
Levee Mile Report Line	14
Start Levee Mile	1.55
End Levee Mile	1.57
Location	Water Side
Category	Earthen Levee
Item	Encroachments
Fire wood on landward levee section. Photo taken 4-27-2012.	
phillips_s_20120516_408.jpg

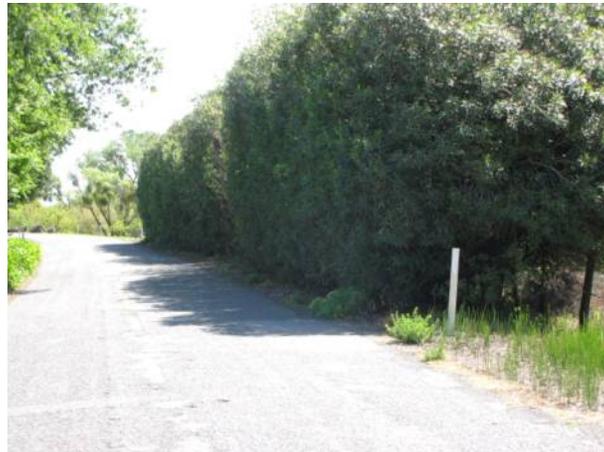
Levee Mile Report Line	16
Start Levee Mile	1.64
End Levee Mile	1.69
Location	Water Side
Category	Earthen Levee
Item	Vegetation
Over growth of oleanders levee mile 1.64 waterside completely blocking view of levee. Photo taken 4-27-2012.	
phillips_s_20120507_405.jpg

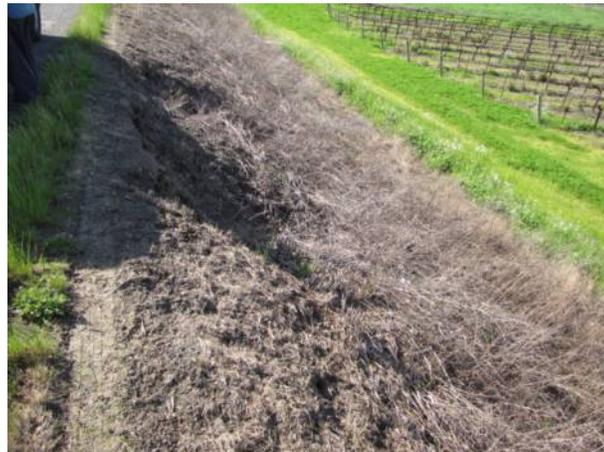
Levee Mile Report Line	19
Start Levee Mile	2.32
End Levee Mile	2.32
Location	Land Side
Category	Earthen Levee
Item	Erosion / Bank Caving
Looking at new erosion site levee mile 2.32 landside slope Unit # 1 RD 556. Photo taken 3-29-2011.	
phillips_s_20120306_247.jpg

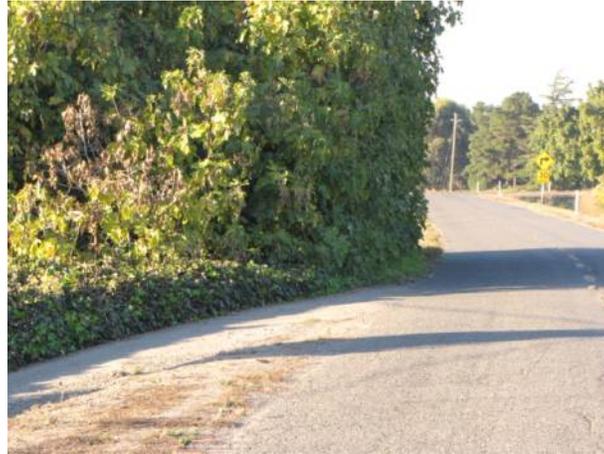
Levee Mile Report Line	20
Start Levee Mile	2.32
End Levee Mile	2.34
Location	Land Side
Category	Earthen Levee
Item	Trim / Thin Trees

Standing on waterside of Unit 1 RD 556 from levee miles 2.34 looking back upstream to levee 2.32 unauthorized tree growth remains on levee section. Photo taken 11-17-2010

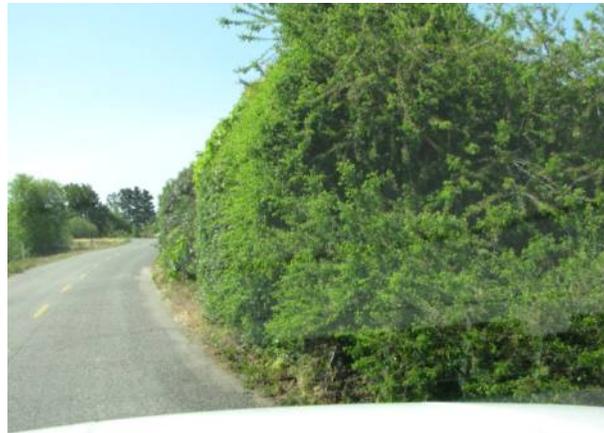
Levee Mile Report Line	22
Start Levee Mile	2.42
End Levee Mile	2.46
Location	Land Side
Category	Earthen Levee
Item	Vegetation

RD 556 Unit 1 unsatisfactory growth landside shoulder and slope. Photo taken 4-27-2012.

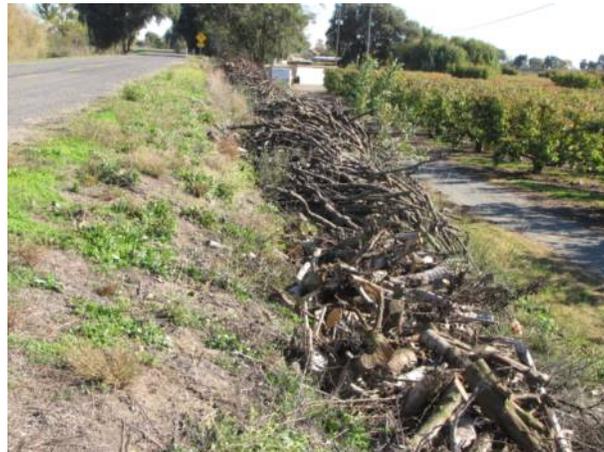
Levee Mile Report Line	25
Start Levee Mile	2.44
End Levee Mile	2.62
Location	Land Side
Category	Earthen Levee
Item	Encroachments

Levee mile 2.44 to levee mile 2.62 firewood placed on landside slope and toe of levee section. Photo taken 11-16-2011.

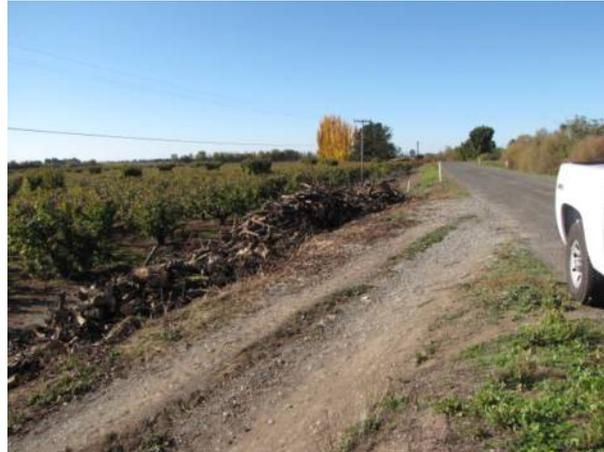
Levee Mile Report Line	25
Start Levee Mile	2.44
End Levee Mile	2.62
Location	Land Side
Category	Earthen Levee
Item	Encroachments
Standing at levee mile 2.62 looking upstream landside at the downstream end of the firewood pile. Photo taken 11-16-2011.	
phillips_s_20120306_241.jpg

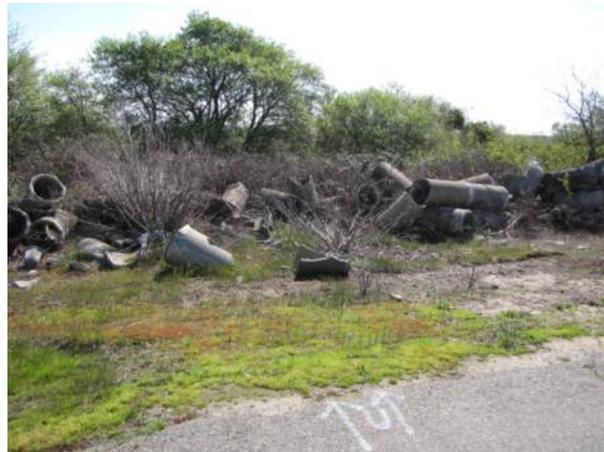
Levee Mile Report Line	37
Start Levee Mile	3.44
End Levee Mile	3.46
Location	Water Side
Category	Earthen Levee
Item	Encroachments
This pipe continue to be on waterward side of RD 556 Unit 1. New photo taken 3-29-2011. Unsatisfactory.	
phillips_s_20120306_253.jpg

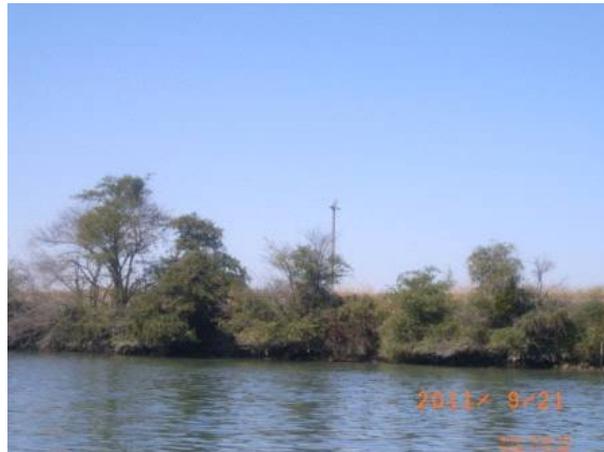
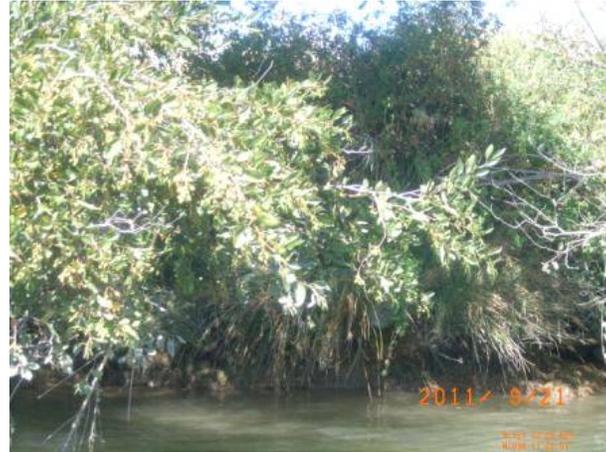
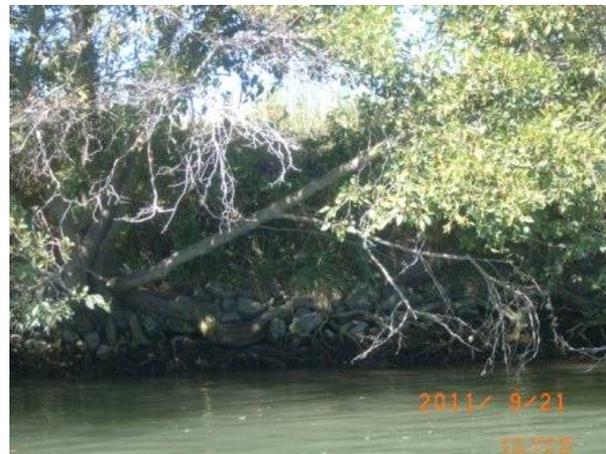
LMR No.	Levee Mile		Category	Item	* Location	+ Rating	Action/Comment	GPS Latitude/Longitude		Issue No. Photo
	Start	End						Start	End	
43	4.95	5.22	Supplemental	USACE Erosion Survey	WS	M Ma	Inspector Comments: 1997 - Toe damaged rock. 1999 - One pocket filled with gravel. 2000 - Eroding beach with some biotech rolls and stakes; some gravel on slope. 2001 - Staked, low fascine walls at bankline. 2005 - Stone revetment in between pockets. 2006 - New rock on upper slope behind brush boxes at the upstream end, Stone is sliding off the hard toe. 2011: No observed change. [2011 Site ID: GEO_7-0_R]	38.189775 ° -121.557729 °	38.188121 ° -121.559413 °	19 Y

Levee Mile Report Line	43
Start Levee Mile	4.95
End Levee Mile	5.22
Location	Water Side
Category	Supplemental
Item	USACE Erosion Survey
USACE 2011 Photo #1	
phillips_s_20120306_248.jpg

Levee Mile Report Line	43
Start Levee Mile	4.95
End Levee Mile	5.22
Location	Water Side
Category	Supplemental
Item	USACE Erosion Survey
USACE 2011 Photo #2	
phillips_s_20120306_249.jpg

Levee Mile Report Line	43
Start Levee Mile	4.95
End Levee Mile	5.22
Location	Water Side
Category	Supplemental
Item	USACE Erosion Survey
USACE 2011 Photo #3	
phillips_s_20120306_250.jpg

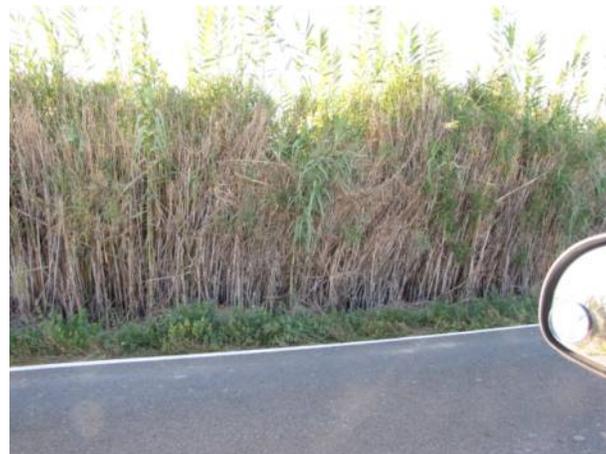
Levee Mile Report Line	2
Start Levee Mile	1.03
End Levee Mile	1.04
Location	Water Side
Category	Earthen Levee
Item	Vegetation
Waterside levee mile 1.03 to levee mile 1.04 RD 556 Unit 2. Photo taken 11-16-2011.	
phillips_s_20120306_257.jpg

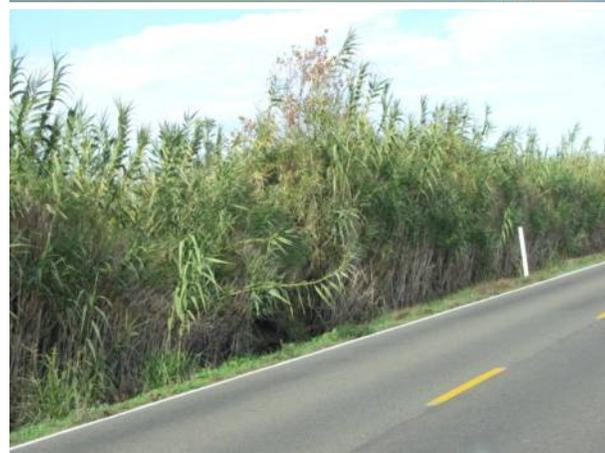
Levee Mile Report Line	4
Start Levee Mile	1.45
End Levee Mile	1.45
Location	Water Side
Category	Earthen Levee
Item	Vegetation
Waterside levee mile 1.45 Unit 2 RD 556. Photo taken 11-16-2011.	
phillips_s_20120306_254.jpg

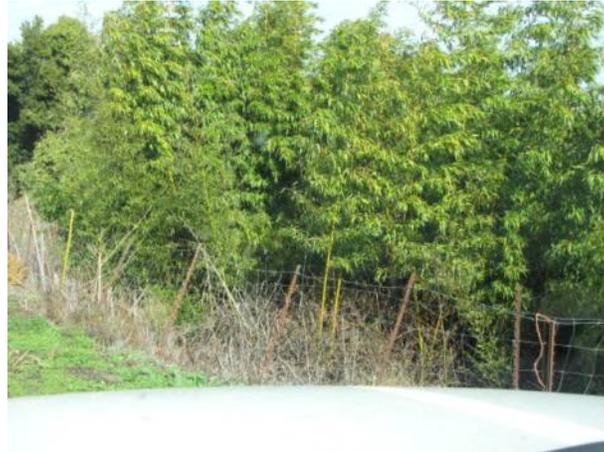
Levee Mile Report Line	6
Start Levee Mile	1.50
End Levee Mile	1.50
Location	Land Side
Category	Earthen Levee
Item	Vegetation
Looking downstream from levee mile 1.50. Photo taken 11-16-2011	
phillips_s_20120306_256.jpg

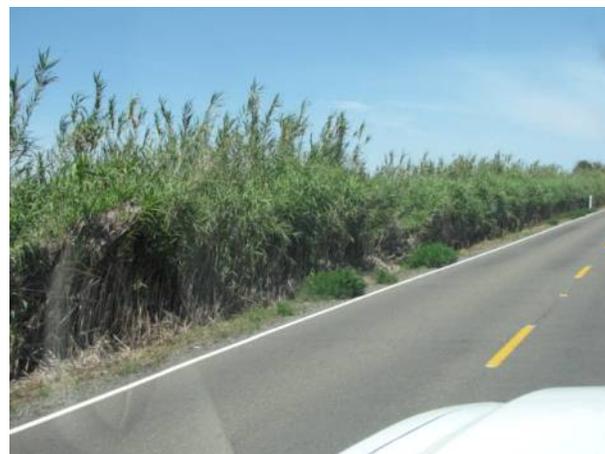
Levee Mile Report Line	20
Start Levee Mile	4.22
End Levee Mile	4.22
Location	Water Side
Category	Earthen Levee
Item	Vegetation
Wild growth of bambo waterside levee mile 4.22. Photo taken 4-27-2012.	
phillips_s_20120507_410.jpg

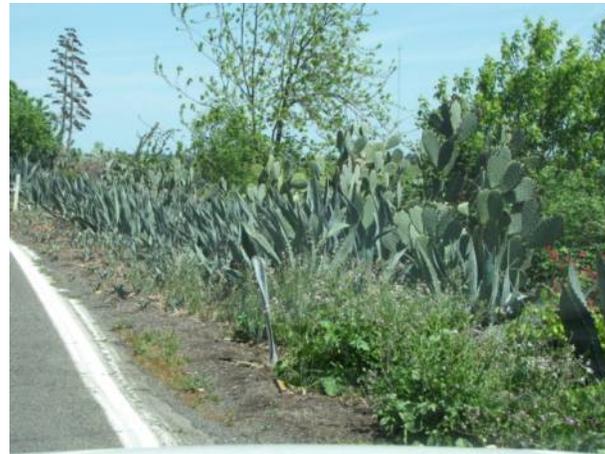
Levee Mile Report Line	33
Start Levee Mile	5.10
End Levee Mile	5.16
Location	Land Side
Category	Earthen Levee
Item	Vegetation
Unsatisfactory growth landside levee mile 5.10-5.16. Photo taken 4-27-2012.	
phillips_s_20120507_409.jpg

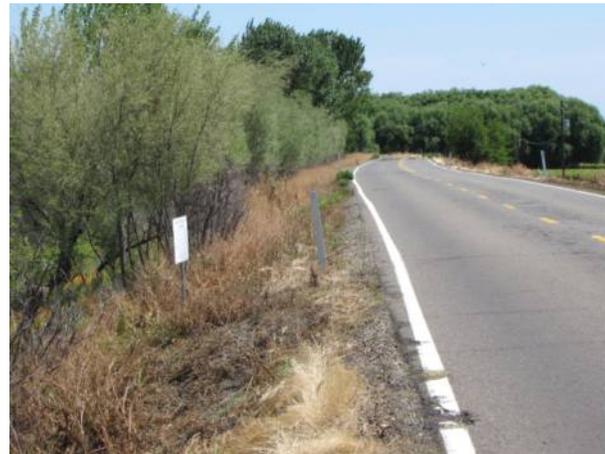
Levee Mile Report Line	38
Start Levee Mile	5.72
End Levee Mile	5.72
Location	Water Side
Category	Earthen Levee
Item	Vegetation
Looking upstream from levee mile 5.72 waterside. Photo taken 4-27-2012.	
phillips_s_20120507_408.jpg
